PULSE REPORT

May/ June

Generic Production Facility Inc.

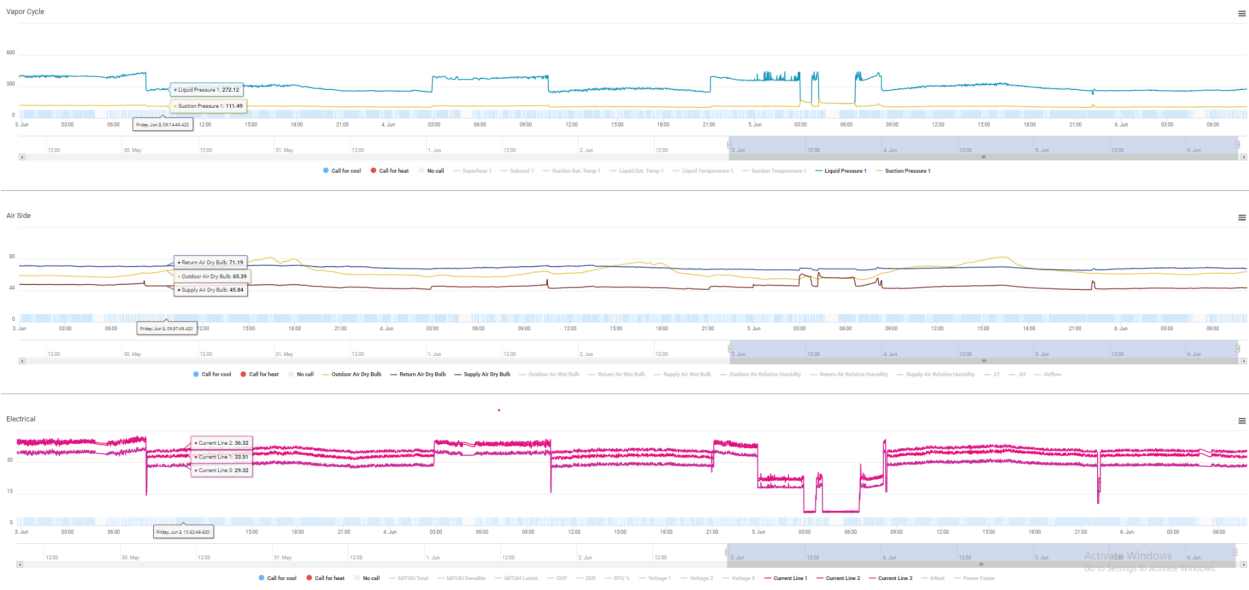
Ground Unit 1

1. Economizer seems to be operating.
2. Fan is always on
3. Pressures seem high for outdoor temp
4. On cool dry days, unit is pulling 40A- RLA is approx 37.5

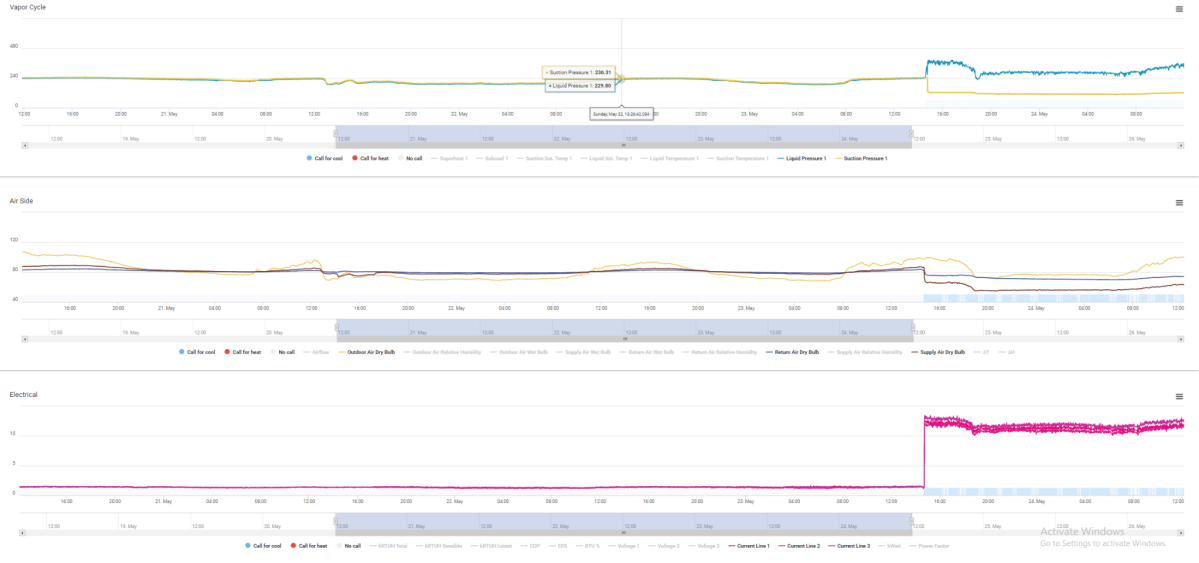
Rooftop Unit 2A

1. Fan always on
2. Has weekend setback
3. Does not have nightly setback
4. Unit is not able to properly cool the space unless ODB drops below 70 degrees
5. short cycles compressor below 70 degrees- 5-10 off, runs High amps (≈23A) for about 3-5 minutes, drops to 10 amps

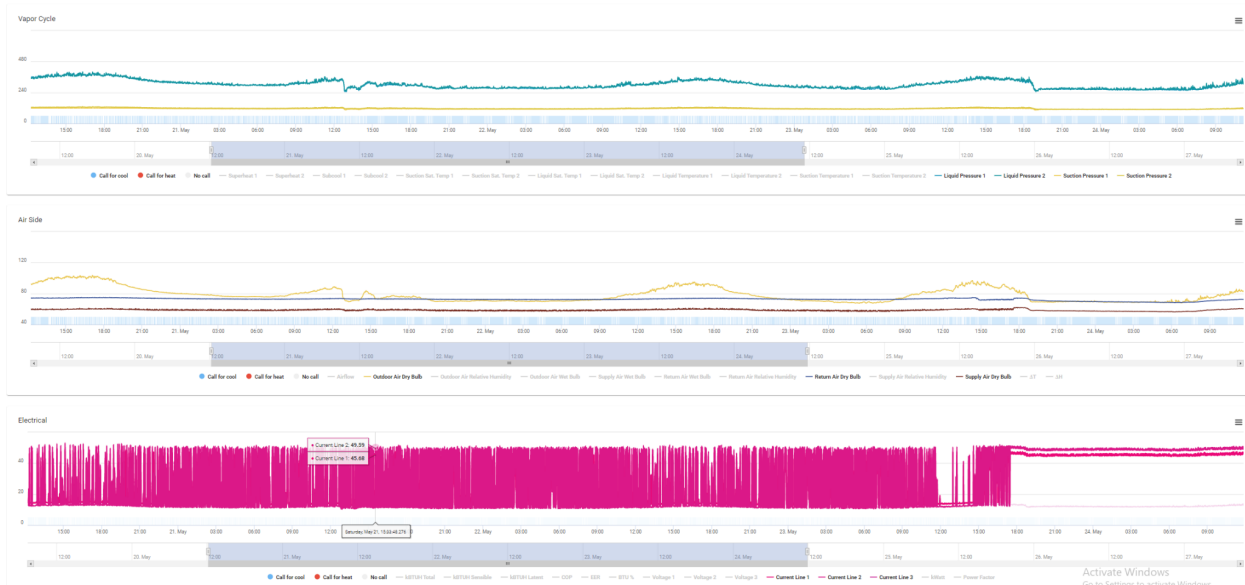
Rooftop Unit 2B

- Both stages are constantly running, even when conditioned space is returning 65 degree air
- CT 1 and CT 2 are reading 48A, CT 3 reads 13A **inspect immediately!** (note; tech believes it may be reheats activating, following up)
- No apparent schedule or setback
